# Step Ladder Instability and Dynamic Loading

## Abstract

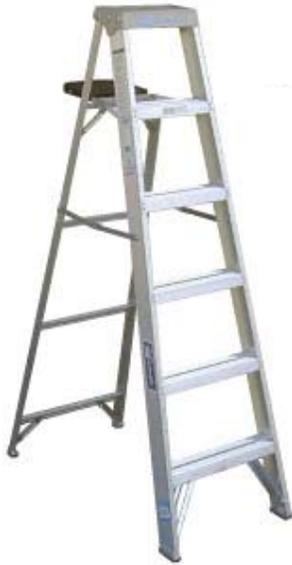
Figure 1: The aluminum step ladder.

A commercial 8 ft type II aluminum ladder was purchased from a local hardware store (see Figure 1). The dimensions of the ladder, all members and the cap were extracted. A finite element model, using ANSYS 6.1, was developed (See Figure 2) [8-12].

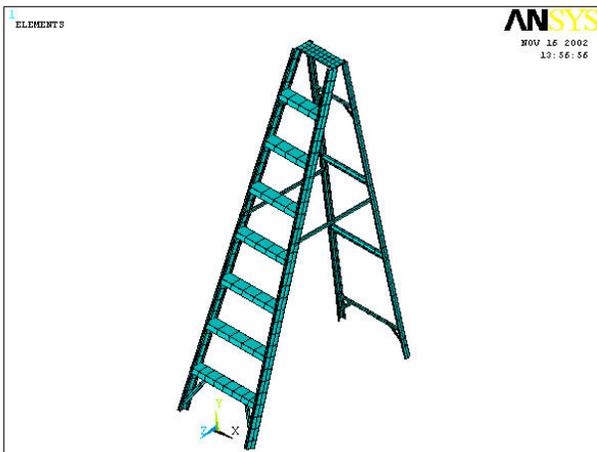
Figure 2: Ladder’s finite element model.

The model included the rungs, the rails, the cap and the spreaders. The pail shelf with its side rails was excluded in the model since previous modelling has shown that they do not contribute to the stiffness of the ladder and have no influence on the result.

ANSYS "beam24" element was used for members with rectangular cross-section. ANSYS "beam44" was used for those members where the cross-section had to be pre-defined or sketched. Areas and moments of inertia

were automatically calculated by ANSYS. ANSYS “shell63” was used to model the top cap as a shell with a uniform thickness of 10mm, defined by the end-nodes of the four rails.

To approximate the flexibility between rungs and rails the rivets, connecting these parts, were modeled by two separate nodes (one on each part) connected by a revolute joint element (ANSYS “combin7”). This element type allows an additional rotation, in this case about the axis of the rivet. The stiffness of the joint can be varied by changing the real constants of this element, affecting the stiffness of the whole ladder. The real constants of this element determine the translational stiffness along three axes and the rotational stiffness about two axes.

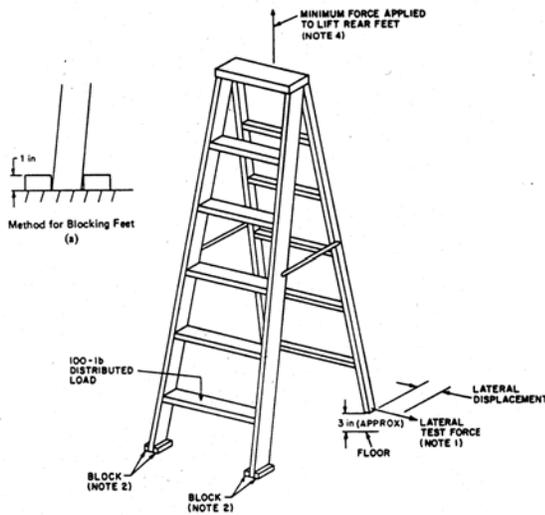
Figure 3: Racking Test according to [1]

The ladder was set in fully open position and both front feet were individually blocked. A distributed load of 100lb was applied on the bottom step and a vertical pulling force at the top cap to lift the rear feet approximately 3 inches above the floor. Further, a lateral force of 6lb was applied to the rear feet where the displacement was measured. For this experiment a displacement of 13.5 inches or 343 mm at the rear feet was obtained. This is well below the allowable limit of 18.7 inches for a 8 foot Type-II ladder.

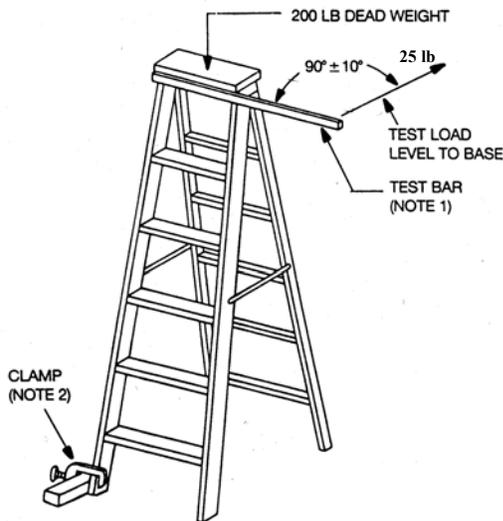
Figure 4: Torsion Stability Test.

In this test a 200[lb] distributed load was applied at the top cap. A horizontal force of 25[lb] directed to the rear was applied at the top cap at a distance of 18 inches from the center line of the ladder (see Figure 4). Movements of more than 1 inch of the ladder with respect to the floor or any visible damage or weakening after release of the test force constitute failure of this test. Three different loads were used in this test as shown in table 2.

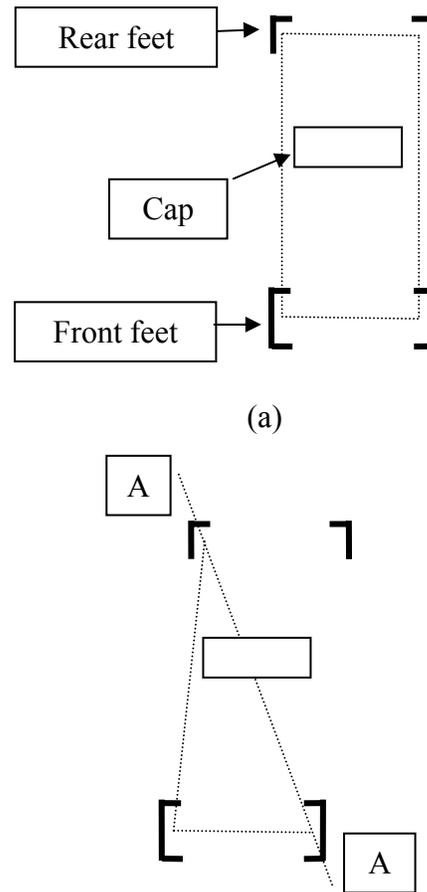
Figure 5: Type II Racking.

Consider the following scenario: A person mounted a step ladder correctly; meaning all four feet are touching the ground and the ladder is not twisted (see Figure 5a). Then, holding a tool box in his left hand he attempts to climb a ladder. He puts his left foot on the first rung and holds the left rail with his right hand pulling himself up. As a result he applies a twisting torque on the ladder and a horizontal force that might lift the rear foot. These two loads might cause the rear feet to move to the right and the right rear foot to be raised and loose contact with ground. Once the user is on the first rung the magnitude of the horizontal force is reduced but due to friction between the left rear foot and the ground and the increase of the vertical reaction force, the foot does not slide back to its original position. At this instance only three feet (front feet and left rear foot) are making contact with ground. As the user continues to climb the ladder is still stable as long as the center of gravity of the user falls inside the triangle defined by the contact point of the three feet (see Figure 5b).

As the user step up to a higher rung, its center of gravity comes closer to the line A-A (see Figure 5b). Reaching to an object on his right, or just shifting his weight from left to right, might locate his center of gravity right to line A-A. At this instance the ladder will rotate to the right (about line A-A) and the rear right foot, which was raised, will hit the ground. As a result, the right rear rail is exposed to impact force that might cause it to fail. In most cases the rail is bent and as a result the ladder collapse and the user falls (see Figure 6). In other cases, the user can lose his balance and fall from the ladder.

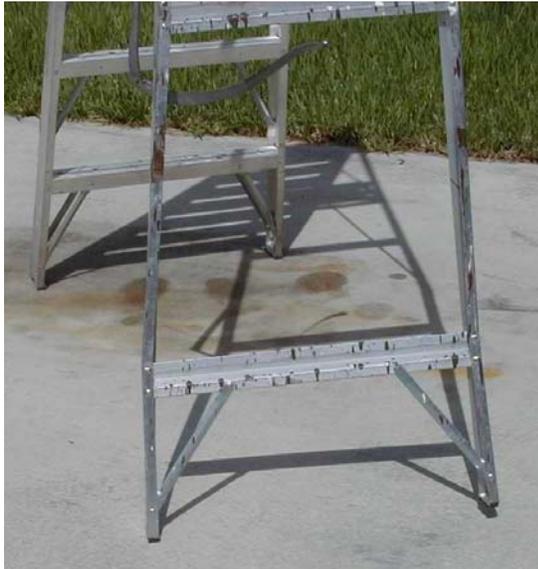
Figure 6: Type II Racking failure.

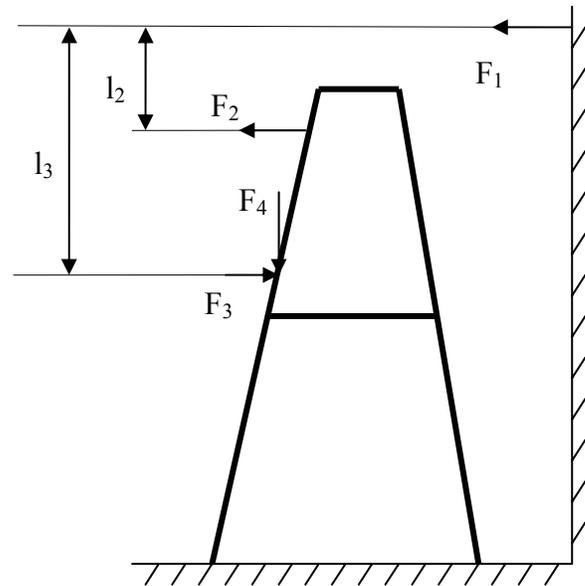
Figure 7: Forces on ladder

In this an impact load was considered. As an example, a case where a person standing on the fourth rung and hammering a nail to the wall in front of him, was analyzed. It is assumed that the user's left hand is using the hammer while his right hand is holding the right front rail. A diagram of the forces are shown in Figure 7 where  $F_1$  is the impact force;  $F_2$  and  $F_3$  are forces applied by the user's hand and feet; and  $F_4$  is the user's weight. The distances  $l_2$  and  $l_3$  were determined by the size of 90% male.

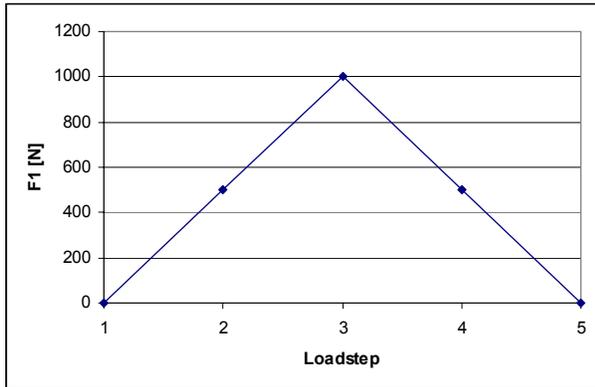
Figure 8: Discretization of the impact load.

A triangular impulse, with a maximum force of 1000N was assumed and was discretized into five loadsteps as shown in Figure 8. The force on the ladder's feet, as determined by the model, are summarized in table 9. As expected, the magnitude of the forces.

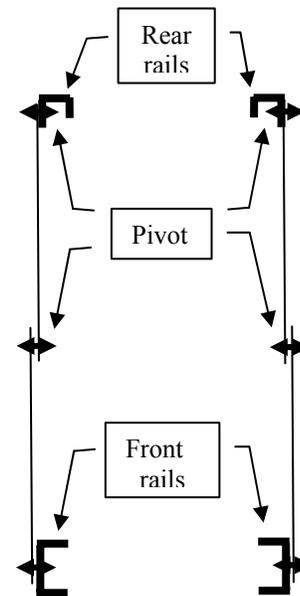
Figure 8: Spreader connection.

One reason the rear feet have large deflection in Type-I racking is that the front and rear parts of the ladder are attached to each other mainly through the top cap. In many implementations the top cap is made of plastic material which makes this connection very flexible. Moreover, the spreaders, attached to the rails with pivots as shown in Figure 9, do not increase the rigidity of this attachment since they form a parallelogram that has negligible resistance to lateral force or twisting torque.

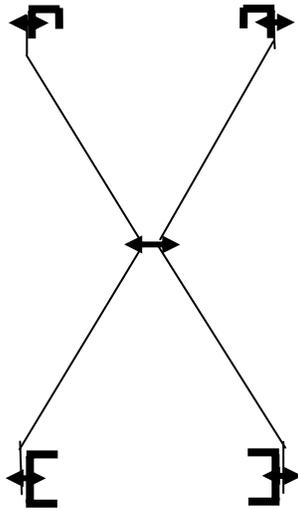
Figure 9: Cross shape spreaders.

To stiffen the connection between the front and the rear of the ladder it is proposed to modify the spreaders as shown in Figure 9. This “cross shape spreader” is by far stiffer than the parallelogram shape mentioned above.

Table 9 provides the deformation results, for the same loading but with the modified spreaders. The results indicate that this spreader arrangement is equivalent to increase the thickness of the front rails by 60% (see Table 8) or their stiffness by 60% (see Table 7). This is a better economical solution compared with the other two.
